# CORNER RECORD

City of BURBANK

Brief Legal Description THE INTERSECTION OF KEYSTONE STREET & PARKSIDE AVENUE

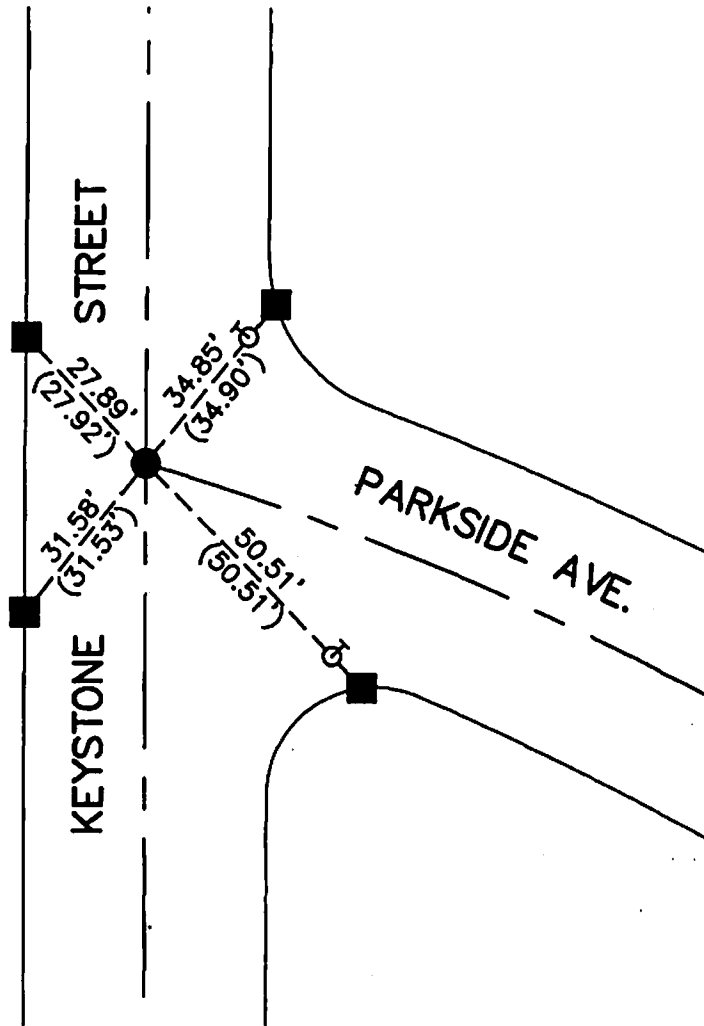
● FOUND SPIKE W/ WASHER "LA COUNTY DPW", ACCEPTED AS CL PER TIES P.W.F.B. 1718-111A. DESTROYED DUE TO CONSTRUCTION. SET MAG. NAIL W/ BRASS WASHER "LS 3983" FLUSH.

■ FOUND LEAD, TACK & TAG "LA COUNTY DPW" PER TIES P.W.F.B. 1718-111A.

( ) INDICATES RECORD DATA PER TIES P.W.F.B. 1718-111A.

LOCATED EXISTING SURVEY MONUMENT PRIOR TO CONSTRUCTION  
TIED OUT AND RESET AFTER CONSTRUCTION.
